MERRIMACK RIVER BASIN
NEW DURHAM, NEW HAMPSHIRE

MERRYMEETING LAKE DAM
NH 00342

PHASE I INSPECTION REPORT
NATIONAL DAM INSPECTION PROGRAM

OCTOBER 1978

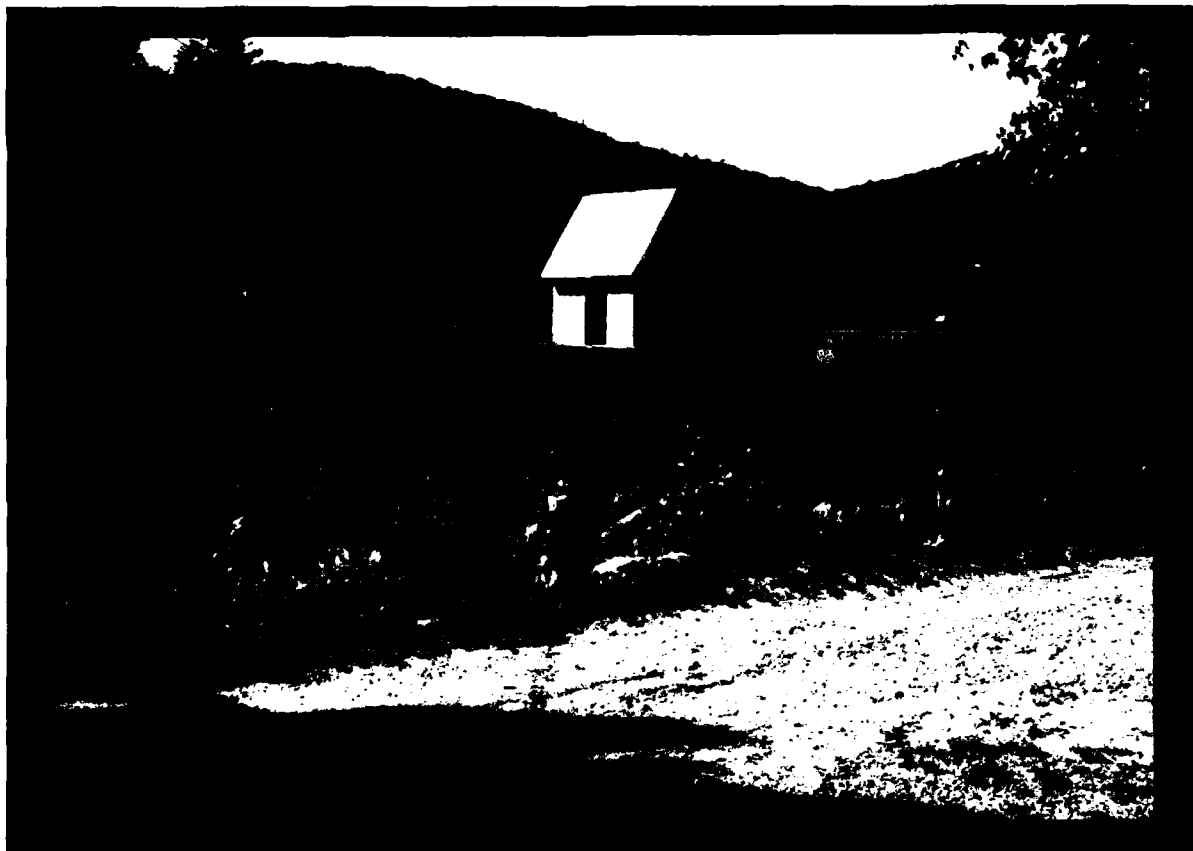
MERRYMEETING LAKE DAM

View of the dam from the downstream side. The low level outlet gate house is in the center. The zone of seepage is demarcated by the end of the cut grass area and the swamp-type vegetation below it.

A zone of seepage was observed in the downstream face of the embankment, approximately 11 feet below the top of the embankment and extending from a point about 54 feet to the right of the low level outlet continuously to a point about 36 ft. to the left of the outlet. The seepage was clean at the time of the inspection. While a considerable quantity of water was observed, an accurate estimate of the seepage could not be made due to the extent of the zone. A measurement made in March 1965, however, records the seepage as being 79 gpm, based on a stream gauge at the Powder Mill Fish Hatchery.

It is recommended that the owner, within 12 months after receipt of this Phase I Report, acquire basic engineering data that would allow the proper assessment of the seriousness of the observed seepage and its effect on the stability of embankment's toe slope.

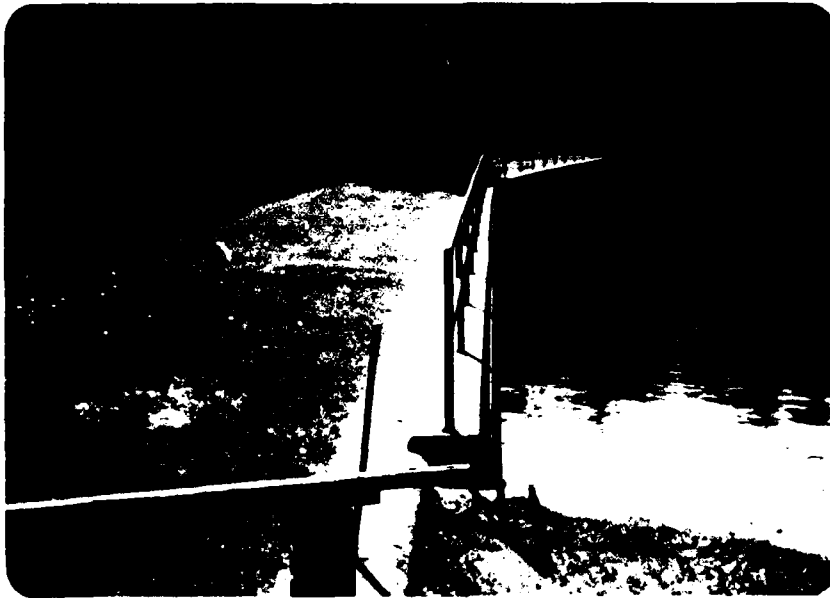
Photo 1 - View of the dam from the left abutment showing the upstream masonry wall and the downstream embankment wall.
